ANALYTICAL INVESTIGATIONS ON A FIRED STUCCO WINDOW IN THE ISLAMIC ART MUSEUM STORE OF CAIRO, EGYPT

Abstract. *The stucco window in this study is kept in the stores of the Museum of Islamic Art in Cairo, Egypt, and bears the number 454/7. This window has been exposed to many damage factors, the most important of which is the fire that broke out in the museum in 2006 AD, in addition to the effect of the water that was used to extinguish the fire. This research aims to study the components of the window (stucco - glass - wood) and identify the transformations resulting from the effect of fire using optical microscopy, scanning electron microscopy coupled with EDX, X-ray diffraction, and infrared spectroscopy. In addition, the microbiological damage resulting from the moisture that saturates the plaster and wood was investigated.*

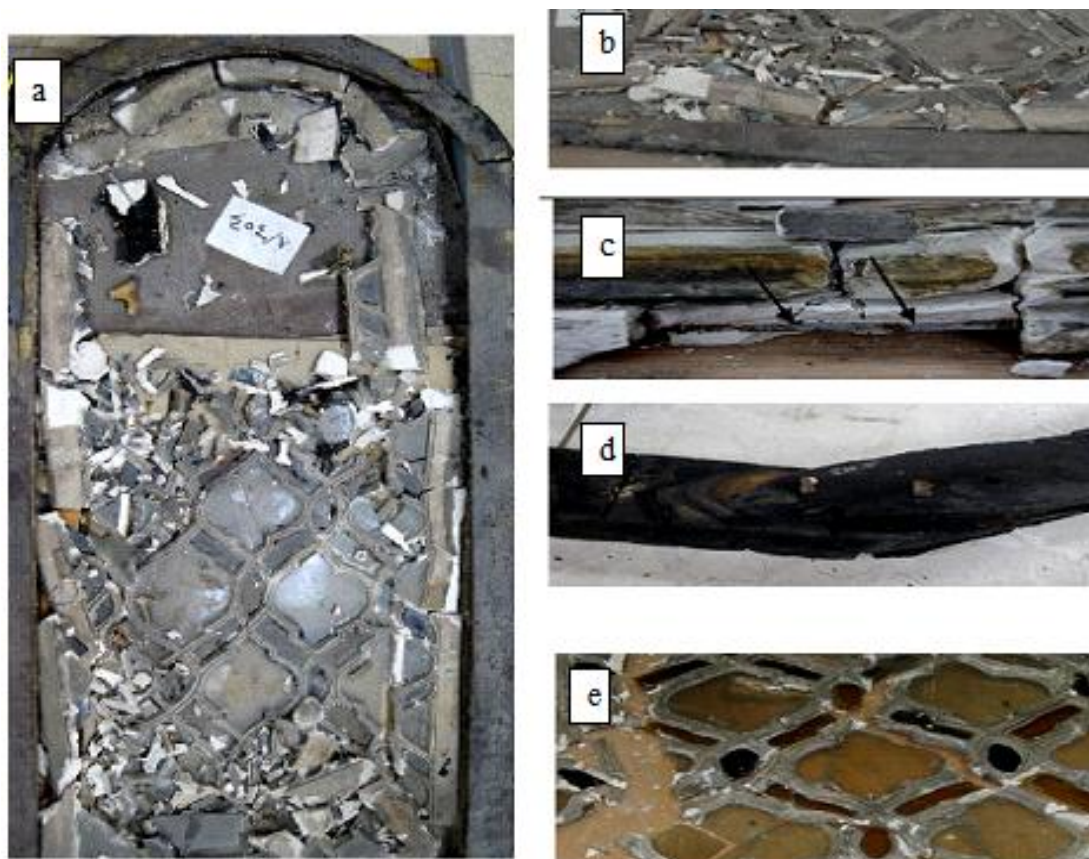
frame in the places of reinforcement. Cracking increases when the iron is exposed to high humidity (the water used to extinguish the fire) [9, 10]; where moisture helps to rust iron and increase its size as a result of the accumulation of iron oxides on its surface [11]. The rust compounds, also seep onto the surface of the stucco decoration through pores and cracks and deform them with hard-to-remove spots (Fig. 1c).

Figure. 1. The deterioration aspects of the stucco window number 454/7 in Cairo's Museum of Islamic Art

burning of part of the frame and its carbonization (Fig. 1-d). The rate of carbonization or charring varies according to the type of wood, its density, and the duration of exposure to fire [8], where the high temperature leads to dry and brittle wood [17]. Also, the use of water to extinguish the fire causes the pores of the wood to swell, which leads to a loss of strength [18]. The structural change of wood caused by severe drying and then moisture absorption causes severe deterioration of wood properties and irreparable damage [19].

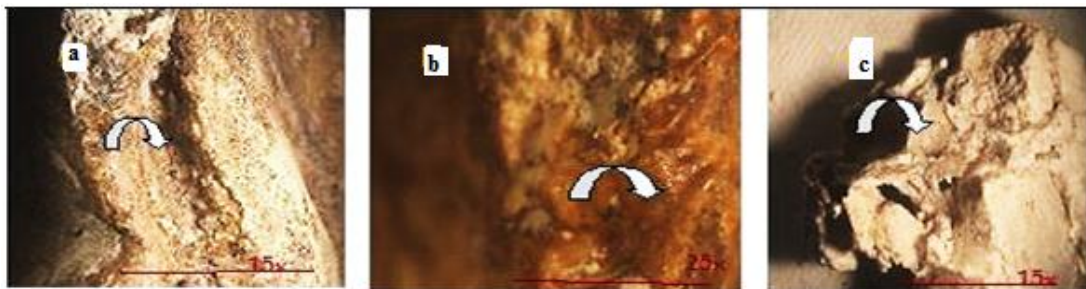
The consolidation material used previously in pasting the stucco decorations is deposited on the surface and do not penetrate the pores (Fig. 4). By examining the glass fillings to identify the signs of damage (Fig. 5), where images from Fig 5a, b represents the yellow glass fillings, is observed clear that there are several air bubbles.

Figure 4. (a, b) The application of the consolidation material on the surface of the stucco decoration, (c) the use of the same material to paste the damaged stucco pieces under a stereo microscope.

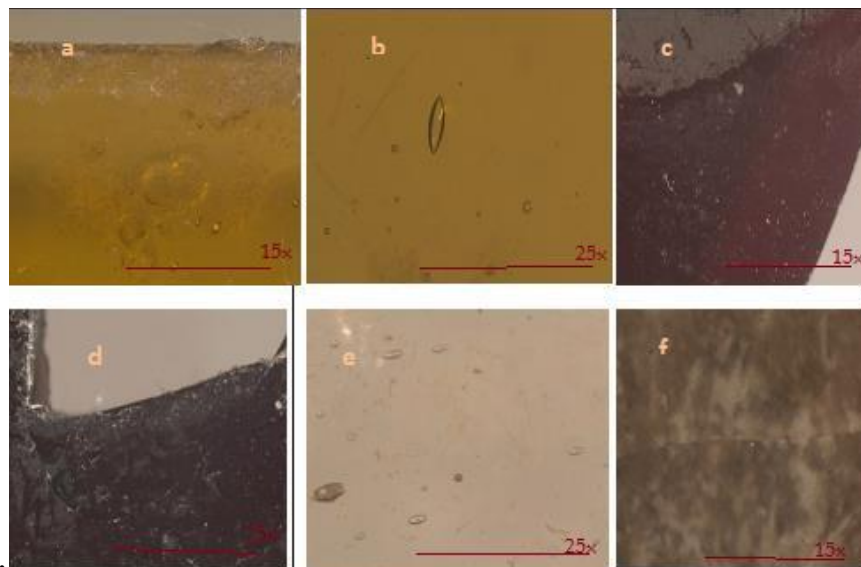
Figure 5. Stereomicroscopy examination (a, b) yellow fillings with air bubbles, (c, d) purple fillings with some broken and previously re-adhesive fillings, (e, f) translucent glass inserts.

The purple glass fillings show the deposition of soot and dust on the surface of the fillings due to the fire, as well as the adhesive material of the glass fillings with stucco decorations; in addition to the presence of a broken part in the sample (Fig. 5d) and re-adhesion (Fig. 5c, d). By investigating the transparent glass fillings, the spread of air bubbles can be seen through the samples (Fig. 5e, f), and this shows the deposition of soot on the surface, in addition to the presence of an impermeable fracture in the sample.

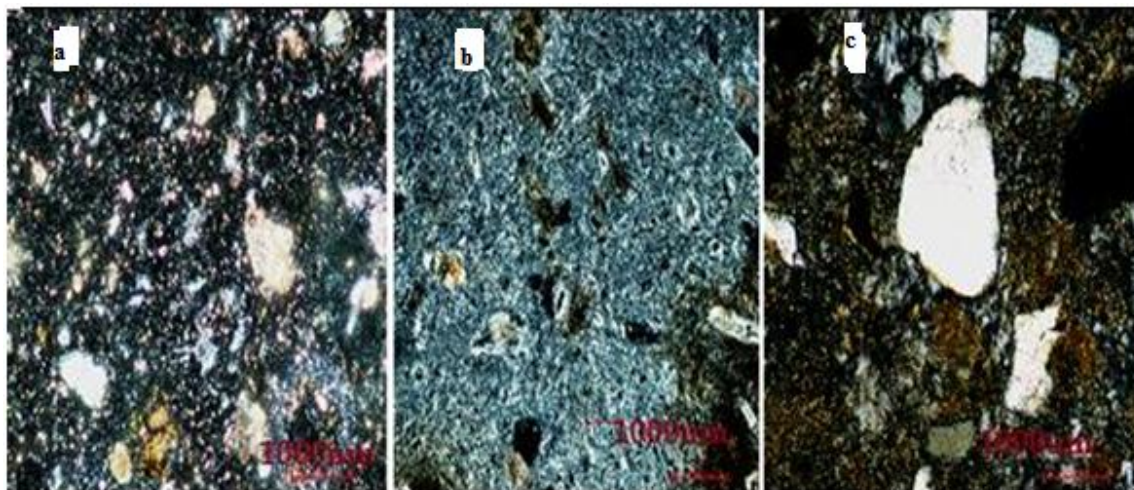
The results of polarized microscopy, on a part of the original stucco that was exposed to fire, shown the presence of minerals from the gypsum, and the accumulation of soot on the surface of the stucco (Fig. 6a). The presence of anhydrite and gypsum crystals (Fig. 6b) is significant, confirming the exposure of the sample to different temperatures, which led to the gradual transformation of gypsum [8]. The examination reveals remnants of a previous restoration where calcite and quartz crystals appear (Fig. 6 c).

Figure 6. Microscopic examination of burnt stucco showing: (a) soot deposits on the surface of the sample; (b) the presence of anhydrite and gypsum crystals; (c) previous restoration with calcite and quartz crystals.

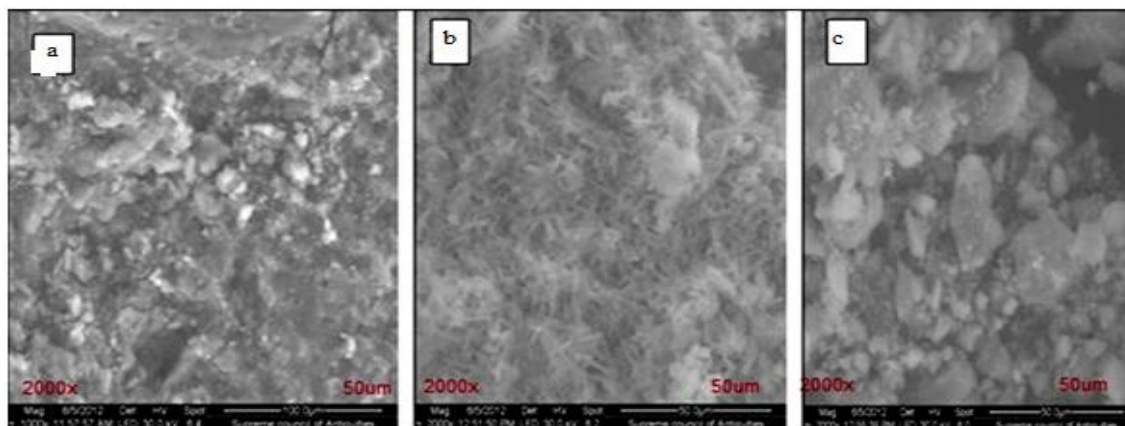
The results of the scanning electron microscopy investigation of stucco samples (Fig. 7a) from the original decoration of the window show an accumulation of soot on the plaster decorations and the disappearance of gypsum particles, as well as the transformation of gypsum into anhydrite. As a result of exposure to heat according to another study [7], it was observed gypsum crystals (Fig. 7b), which may mean one of two things: the sample was unaffected by the fire, or it was exposed to fire and a portion of the gypsum was converted to anhydrite, which was then transformed back into gypsum after exposure to moisture [26]. The images examination showed the use of components different from the components of the original stucco decoration, where large crystals of calcite appear in addition to the presence of quartz (Fig 7c).

Figure 7. SEM micrograph (a) depicts the scattering of soot; (b) gypsum crystals; (c) calcite crystals and quartz.

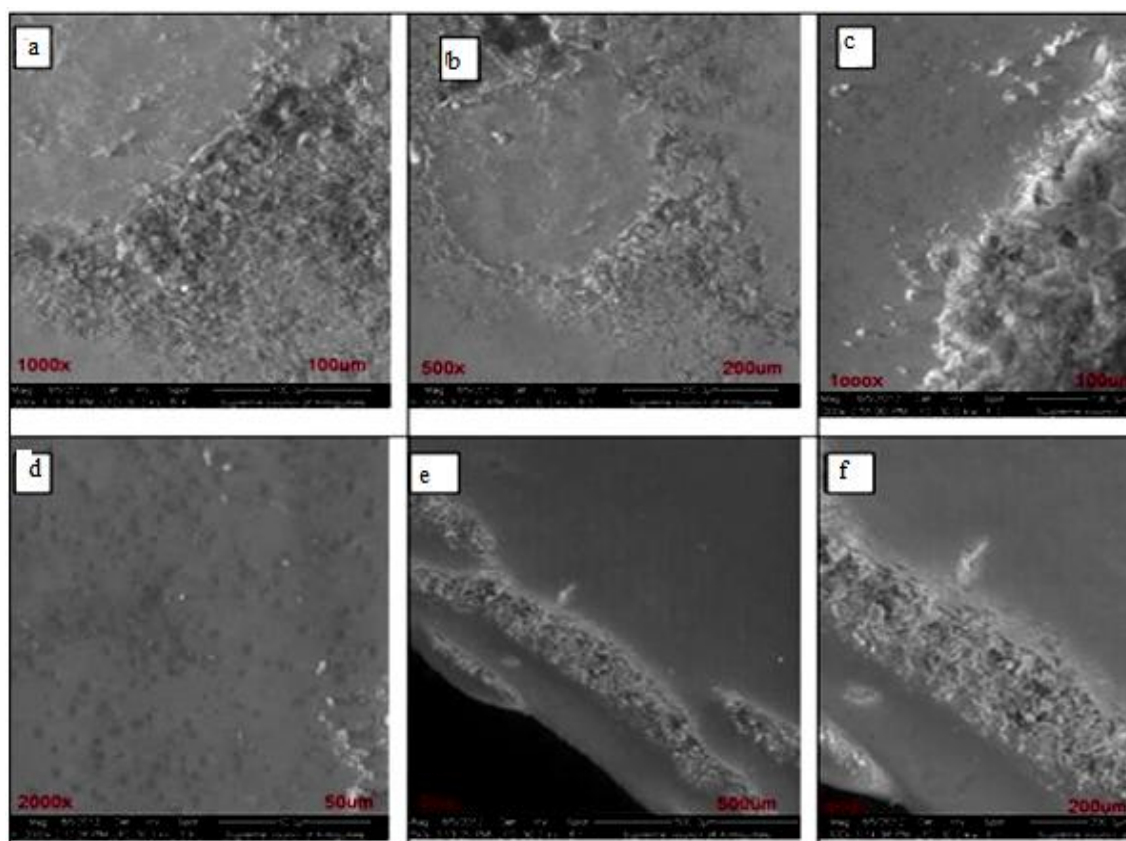
Figure 8. SEM micrograph for glass fillings shows; (a, b) erosion and weakening of the surface of the yellow fillings; (c, d) the stability of the purple fillings with some spots on the surface; (e, f) the stability of the the transparent fillings with some dust and dirt

The investigation of glass samples using the SEM technique, widely used in studying the surface appearance of antique glass, led to detecting have detected its corrosive surfaces and clarifying damage [27, 28]. Various samples were examined, and some glass fillings were represented. The results of the appeared examination are as follows (Fig. 8a-f): Fig. 8a-b represents yellow glass fillings with the accumulation of dust and dirt that appears on the surface, as well as erosion and weakness in the sample surface; Fig. 8c-d represents the purple glass fillings, showing the consistency and stability of these fillings, with spots on the sample surface; Fig. 8e-f the transparent fillings, the examination shows that the transparent glass is stable, but there is some dirt on the surface.

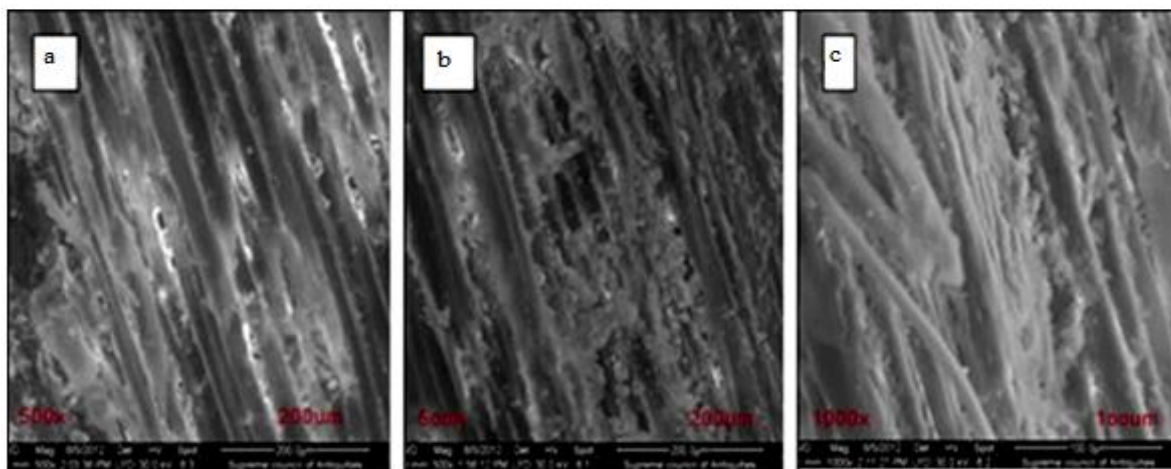
On the other hand, in order to investigate the timber frame samples and to verify the surface shape and characteristics of wood as well as to determine the type of wood used in the timber frame, the SEM technique was used [18]. Also, this method was used to examine the microscopic deterioration in the anatomical structure of wood [29]. The results of the investigation are presented in Fig. 9. The destruction and damage to the middle plate of the wood, which led to the separation of the woody cells from each other, as well as the collapse of the cell walls and their layers [25] it can see in Fig. 9a. On the other hand, the spread some cracks and cracks in the layers of the cell wall, the separation of the layers of the cell wall, and the destruction of adjacent holes [25], as well as the appeared cracks due to exposure to wetness and then dehydration at high temperatures [22] are highlighted in Fig. 9b. In addition, the appearance of fungal hyphae, which confirms the fungal infection due to exposure to high humidity is shown in Fig.9c [17].

Figure 9. (a,b,c) SEM micrograph for wood frame Shows damage to wood cells as a result of exposure to high temperatures and moisture and the appearance of fungal hyphae in (c).

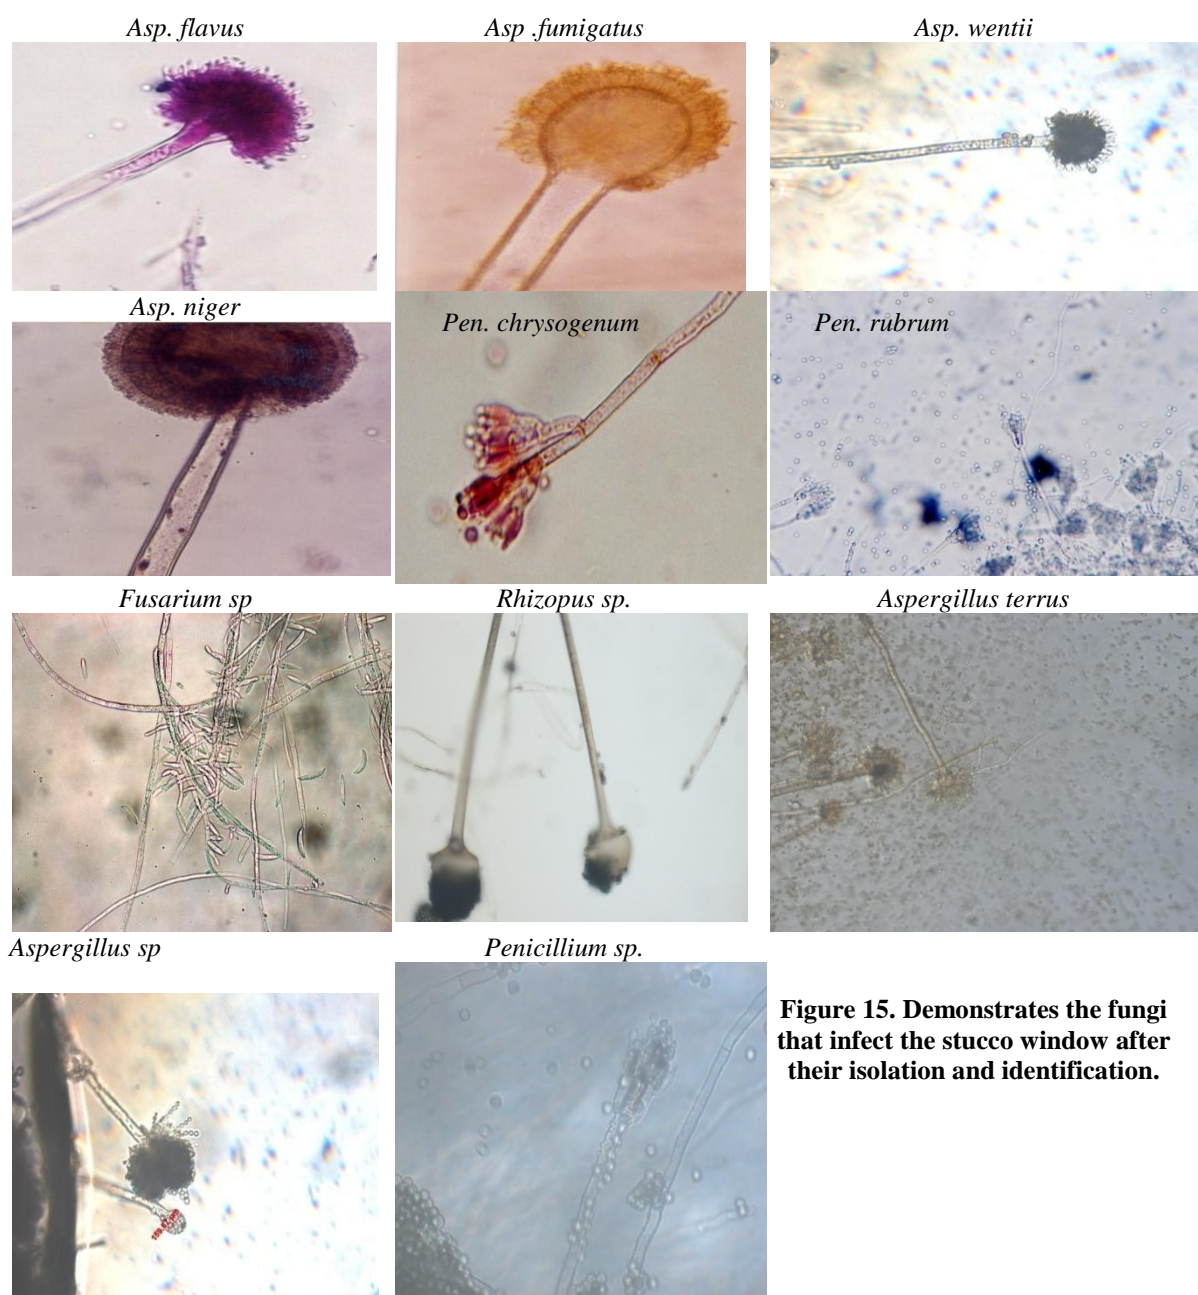
Fungi have been identified according to various methods presented in different studies [45, 46]. The results showed (Fig. 15) that the fungal growths on the window including *Aspergillus flavus*; *Asp fumigatus*; *Asp Wentii*; *Asp Niger*; *Pen Chrysogenum*; *Pen Rubrum*; *Fusarium sp*; *Rhizopus sp*; *Aspergillus terrus*; *Aspergillus sp*; *Penicillium sp*. These results are in agreement with various studies in this field [47-50].

Figure 15. Demonstrates the fungi that infect the stucco window after their isolation and identification.
