MULTI-ANALYTICAL TECHNIQUES FOR THE ARCHAEOMETRY STUDY OF THE STAINED GLASS WINDOW FROM THE ROYAL PALACE AT EDFENA, EGYPT

Abstract. *This work aims to study the case of the stained glass window at the Royal Palace in Edfena, Egypt. The research also aims to identify the chemical composition and diagnose the manifestations of damage on the stained glass window. Therefore, the examination and analytical study were conducted using several different techniques, including AutoCAD, digital and stereo microscopies, scanning electron microscope - X-ray energy dispersion, X-ray diffraction, and microbiological examination. The microscopic study revealed that the surface of the painted glass suffers from the presence of layers of damaged products, which obscure the decorations and lead to opacity. Light holes spread across the layers of different paints with varying sizes, and pits appear as a result of corrosion. Using EDX, the element responsible for the color in the painted glass layer was determined, as well as the composition of the lead came. XRD was used to identify the crystalline compounds in the painted glass layer and the putty composition. In the end, an appropriate treatment pl

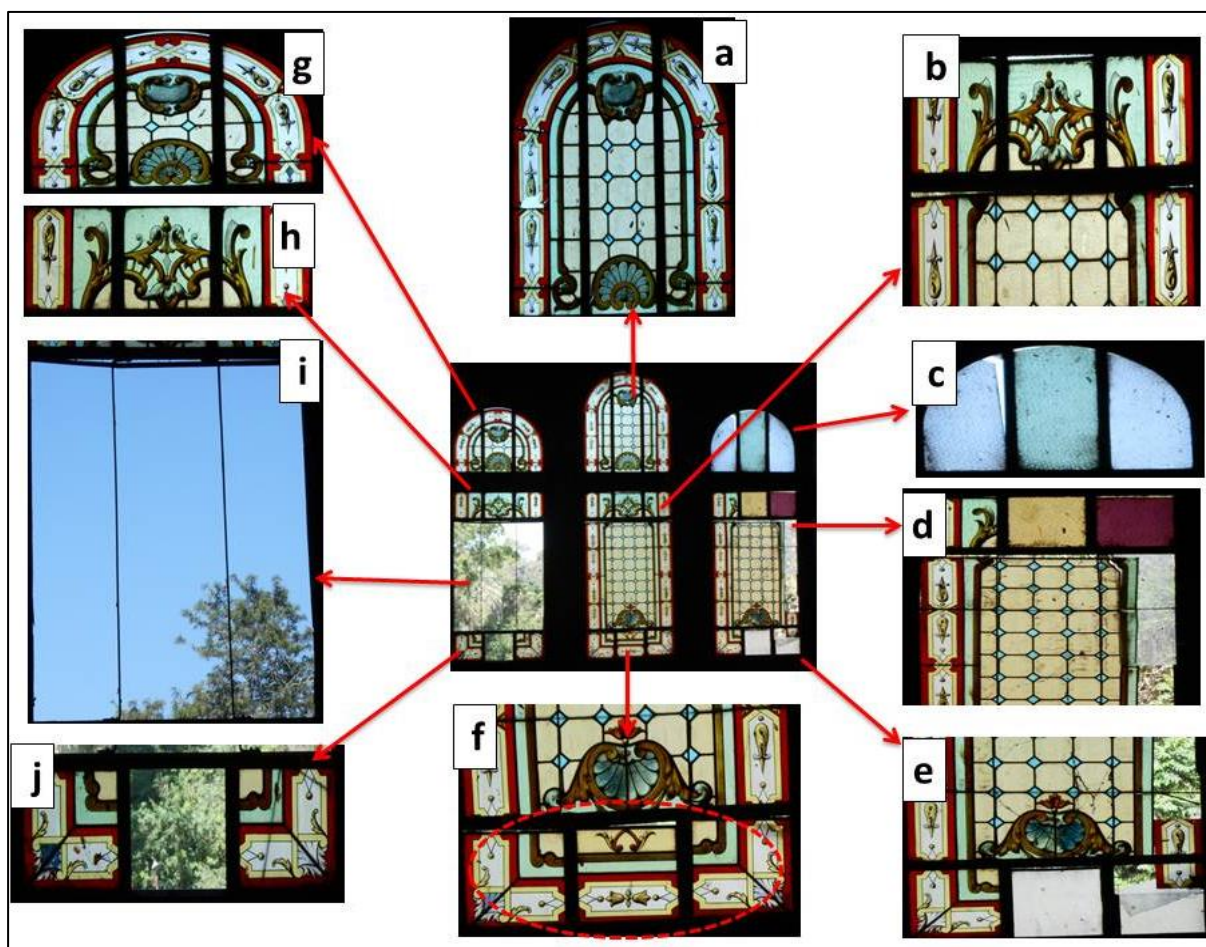
Curvature (Fig. 4a) is observed, indicating that the glass window is curved with a convex inward and concave outward curvature. This curvature arises from the weakened state of the lead strips, which compromises the structure and cohesion of the window. The combined effect of strong winds and temperature fluctuations contributes to the slackness and fragility of the lead strips, eventually leading to the subsequent loss of glass pieces [26].

Illumination (Fig. 4b) refers to voids that expel glass pieces from the lead cavity when the putty material is lost and the lead strips harden. These openings allow light to penetrate, distorting the window's aesthetic appearance [27]. This marks the onset of glass piece collapse, as increased pressure causes the voids to expand until the glass pieces dislodge and become lost.

The use of heterogeneous glass for the missing parts (Fig. 4c, d, e) implies that the window underwent restoration work some time ago, and the missing glass pieces were replaced with colorless or improperly colored glass, which distorts the overall aesthetic design. Additionally, a significant accumulation of dust and cobwebs is observed on the surface of the window glass (Fig. 4d, e).

Limpness (Fig. 4f) denotes a general weakness in the lead strips, causing a significant reduction in their ability to hold the glass pieces in an upright position. This results in a lack of cohesion within the lead cavity and the loss of the putty material [28]. Limpness is particularly noticeable in the lower part of the window due to increased loads in that area.

Figure 4. Various aspects of deterioration in stained glass window (a) curvature of stained glass; (b) illumination of the glass; (c, d, e) use of heterogeneous glass for the missing parts; (e, d) cobwebs and dirt stuck to the surface; (f) limpness of lead strips; (g, h) darkening of glass paintings; (i) loss of glass pieces; (j) cracks and loss of glass pieces.

Darkening (Fig. 4g, h) indicates the opacity or loss of transparency in the glass resulting from high humidity. The coastal environment with heavy rainfall severely affects the window, causing the glass to become opaque and lose its transparency [29].

Due to the fragile nature of glass, glass pieces are susceptible to cracking and breakage under pressure. This vulnerability becomes more pronounced when the lead strips lose their strength and flexibility, leading to twisting and exerting pressure on adjacent glass pieces [30], resulting in the formation of cracks (Fig. 4j). As this phenomenon worsens, it leads to the eventual loss of glass pieces (Fig. 4i, j).

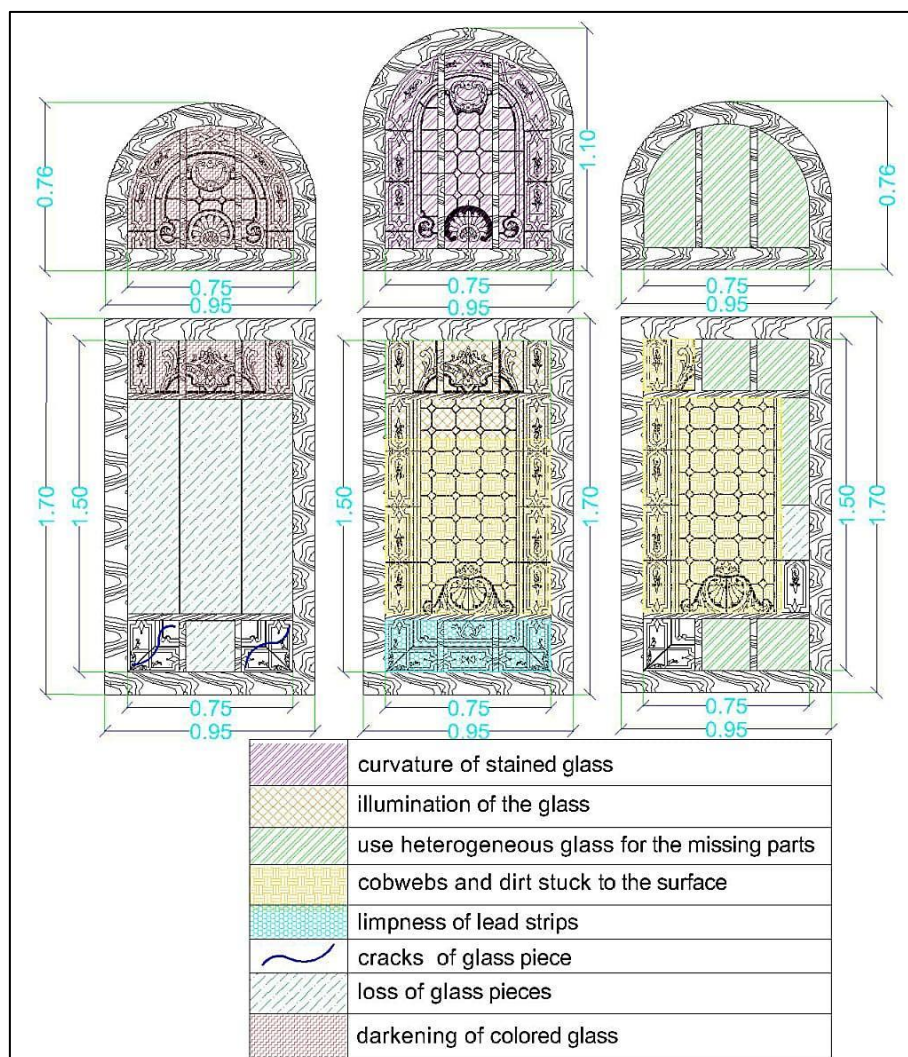
The dimensions of the stained glass window were confirmed and documented using the AutoCAD software. It is used to precisely record the many types of deterioration that are present in the glass window (Fig. 5).

Figure 5. Documentation of the stained glass window using AutoCAD.

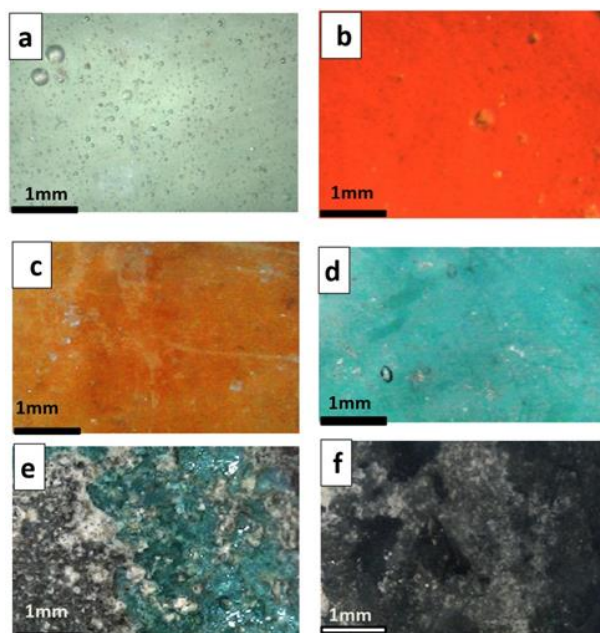
Digital microscopy is regarded as one of the most important techniques available to restorers, and its images aid in assessing the aspects of deteriorated objects [31]. It is observed that the surface of the transparent glass bearing the paint layers is full of air bubbles (Fig. 6a). Air bubbles are a manifestation of manufacturing defects resulting from the glass not achieving a homogeneous mixture during the melting process, representing the weakness of the glass [32]. Additionally, pitting is observed on the surface of the red paint layer (Fig. 6b). Scratches are visible on the surface of the brown paint (Fig. 6c). The surface of the turquoise paint shows air bubbles and fine cracks (Fig. 6d), as well as the deposition of dust, dirt, and pits filled with corrosion products (Fig. 6e). The surface of the lead came exhibits a layer of oxidation and damage to the lead metal in the form of white calcifications on the surface (Fig. 6f).

Figure 6. Digital microscope images showing the results of the samples examination (a) air bubbles on the transparent glass; (b) pits on red painted glass; (c) scratches on brown painted glass; (d) microcracks and air bubbles on turquoise painted glass; (e) accumulation of deposited layers of dust and dirt on the surface of the turquoise painted glass; (f) the lead came with an oxidized surface.

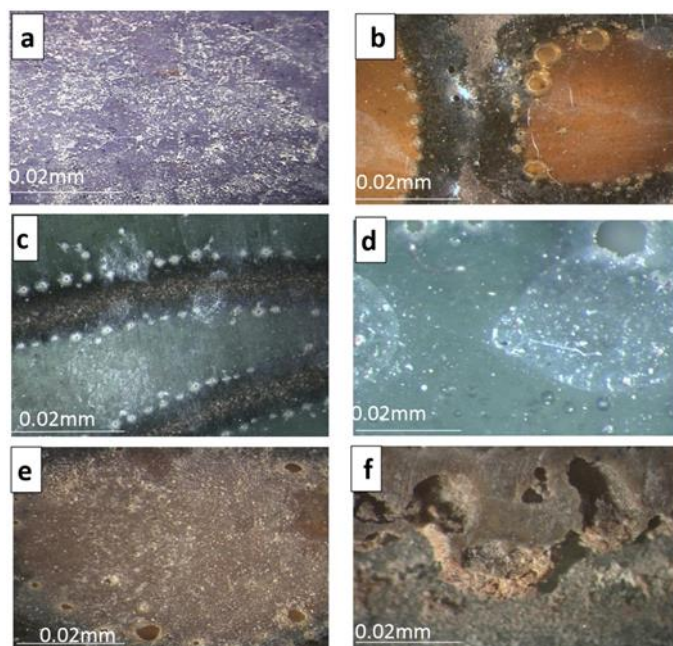
Stereo microscopy is used to observe and analyze changes in the characteristics of glass surfaces, aiding in estimating potential damage. On the surface of the transparent glass, cracks, fissures, and opacity can appear (Fig. 7a).

Figure 7. Stereomicroscope images showing the results of the samples examination (a) cracks, fissures, and opacity of the glass surface; (b) pits and blisters on the brown painted surface; (c) optical holes and pits parallel to the tracing line in the turquoise paint; (d) craters on the turquoise painted surface; (e) deposition of deterioration products on the surface of the brown painted glass; (f) lack of cohesion between the grains of the putty sample.

Pits and blisters are noticeable in the brown paint layer surrounded by black liner, leading to damage to the paint layer (Fig. 7b) [33]. Optical holes and pits appear parallel to the tracing line in the turquoise paint (Fig. 7c). Additionally, the surface of the turquoise paint exhibits craters resembling volcanic craters in the form of deep pits (Fig. 7d). Deposition of corrosion products in the form of a thin white layer on the surface of the brown painted glass, resulting in opacity, is observed (Fig. 7e) [34]. The examination of the putty used to cement the lead strips and the glass reveals a lack of cohesion between its grains, weakness, and deterioration (Fig. 7f).

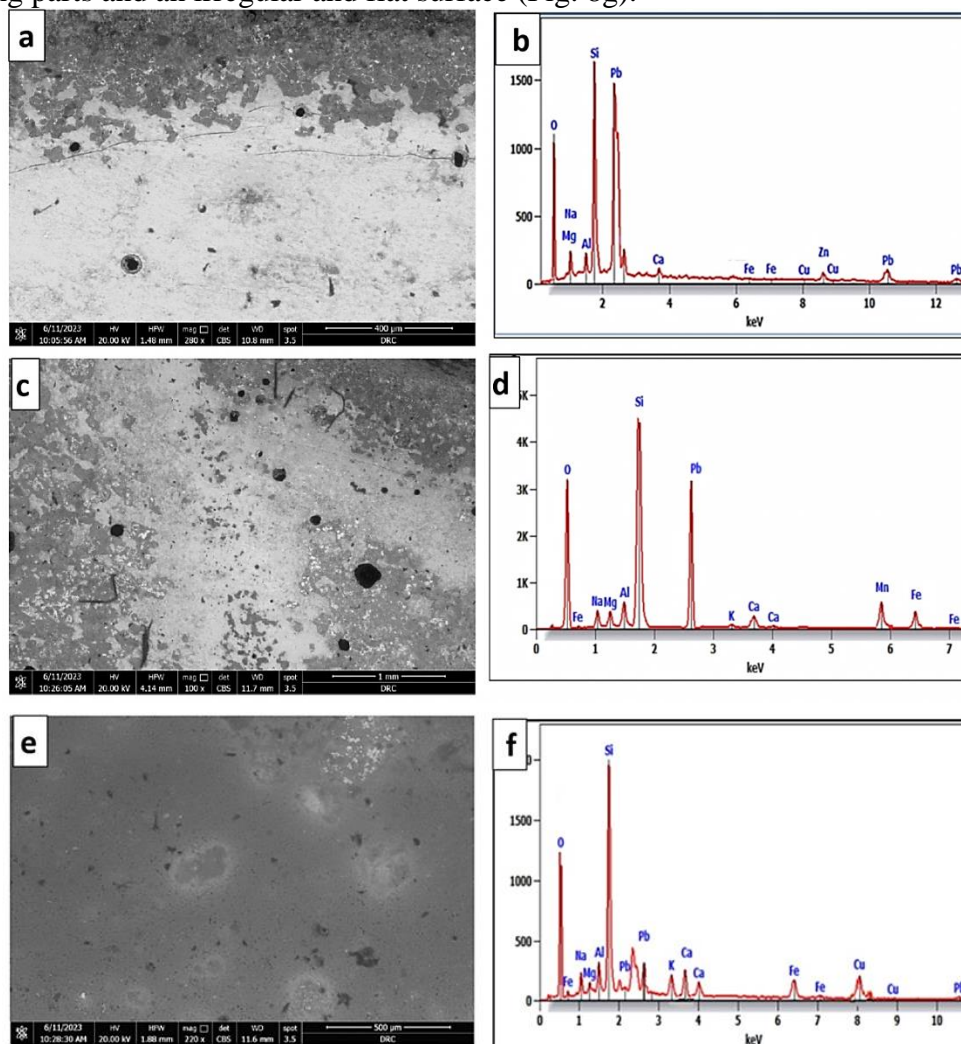
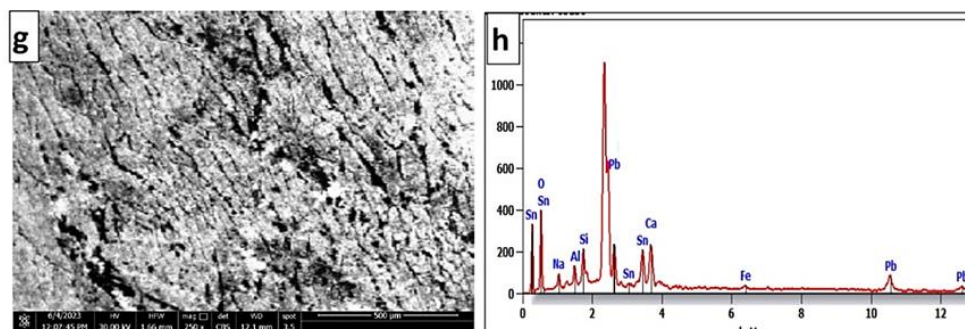
Examining the glass samples using the SEM method, which is extensively used to evaluate the surface appearance of the painted glass sample, resulted in the detection of corroded surfaces and the clarification of deterioration. The red paint sample (Fig. 8a) shows an irregular distribution of painted oxides on the glass surface and cracks. The brown paint sample (Fig. 8c) exhibits a layer of superficial deposits resulting from corrosion processes, along with holes and pits on the surface. The turquoise paint appears stable but contains some pores (Fig. 8e). The lead sample shows apparent corrosion in the lead layer, with sunken and protruding parts and an irregular and flat surface (Fig. 8g).

Figure 8. SEM images and EDX spectra of the analyzed samples (a, b) red paint; (c, d) brown paint; (e, f) turquoise paint; (g, h) the lead came sample.

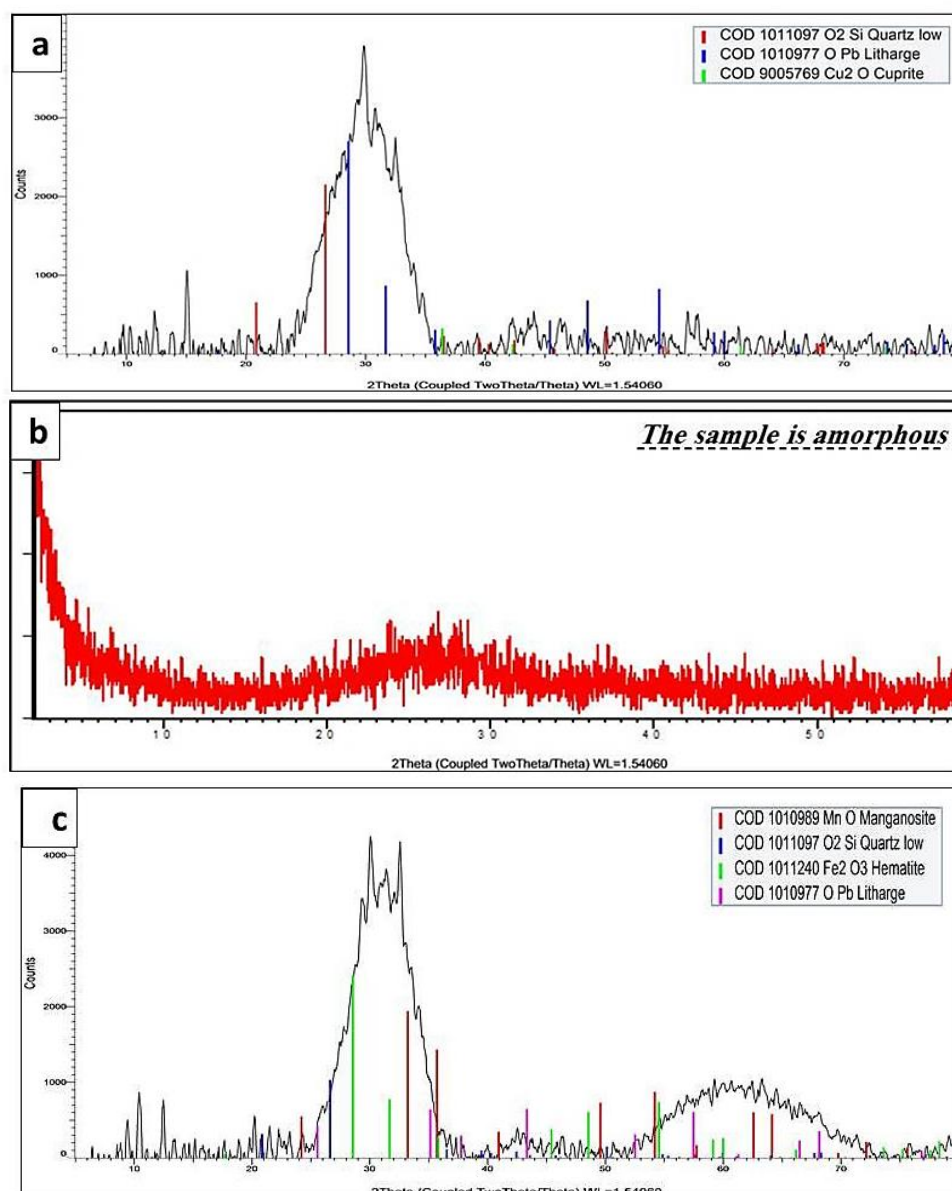
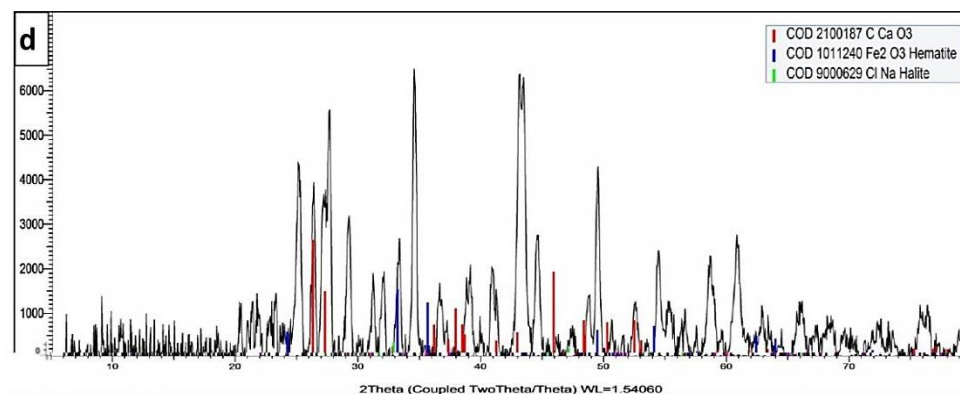
This method is used to qualitatively determine compounds in crystalline materials since the rays interact with the crystalline structure [51]. In this study, XRD is employed to analyze painted glass samples to identify the crystalline patterns representing damage to the paint layers, as it has the same properties as glass in that it is an amorphous material [52]. The sample of the red-painted layer (Fig. 9a) consists of quartz (48%), cuprite (17.5%), and lead oxide (34.5%). Quartz is an essential component of the painted glass layer, while cuprite is responsible for the red color [53]. Lead oxide is a fluxing agent and an essential component in the color mixture [54]. The turquoise paint layer is amorphous (Fig. 9b), indicating that it has not been damaged, which aligns with the results obtained from the EDX. The sample of the brown paint layer consists of quartz (40.9%), manganese oxide (10.6%), hematite (18.5%), and lead oxide (30%) (Fig.9c). Quartz and lead oxide are the main components of the painted layer. In contrast, manganese oxide and hematite are responsible for the brown color [55]. The putty sample (Fig. 9d) consists of calcite (81.4%), halite (15.9%), and hematite (2.7%). The presence of halite salt indicates that the putty has been damaged and the salts have crystallized within it [56].

Figure 9. X-ray diffraction pattern showing the results of the studied samples. (a) red paint; (b) turquoise paint; (c) brown paint; (d) putty sample.

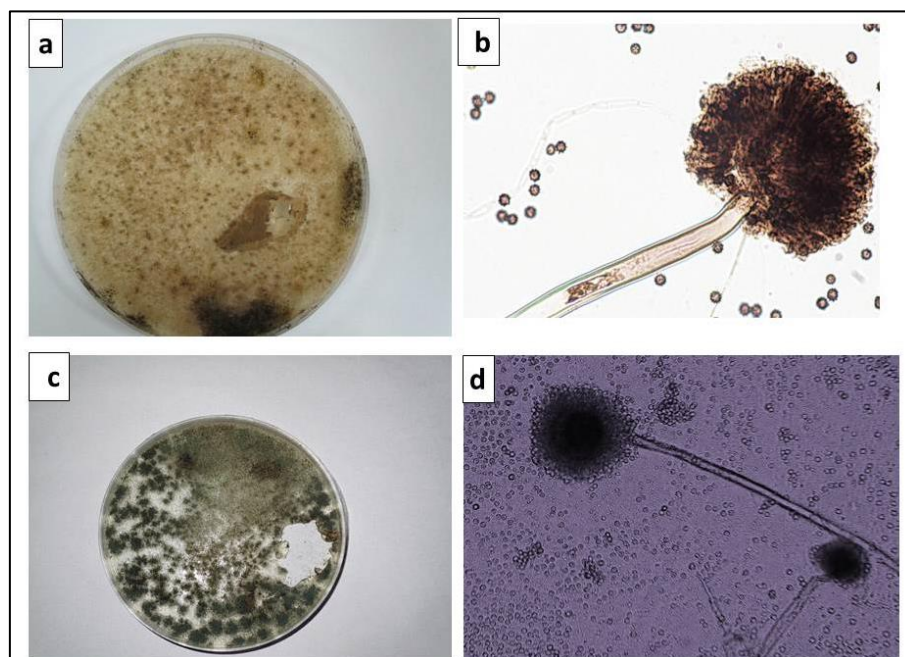
The study revealed the growth of the *Aspergillus flavus* fungus, depicted in (Fig. 10a), as a yellowish-green color in a petri dish and visible under the microscope in (Fig. 10b). Additionally, the presence of *Aspergillus niger* fungus was observed, appearing as a blackish-brown color (Fig. 10c), and visible under the microscope as shown in (Fig. 10d). These fungi are widespread. They produce spores known as ascospores, which contribute to the physical and chemical damage of the window components [57].

Figure 10. Identification of the fungi that infect the stained window glass (a, b) *Aspergillus flavus* fungus; (c, d) *Aspergillus niger* fungus.

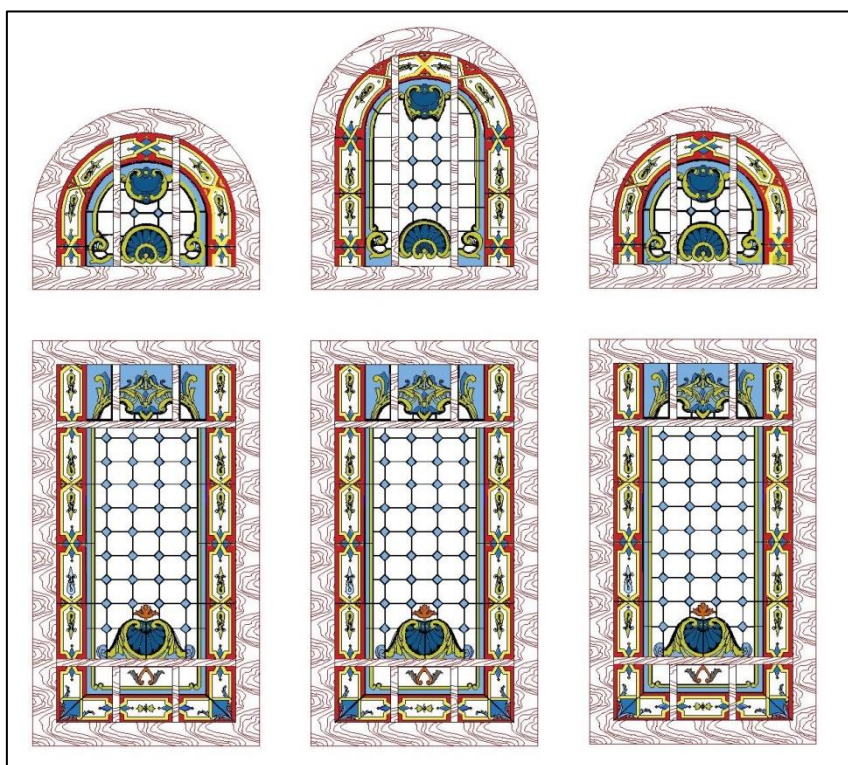
Figure 11. Shows the stained glass window after the imaginative conservation, with the missing parts completed using original decorations and colors

Removing the window from its current location due to its height and transporting it to the workplace is preferable to facilitate maintenance and conservation operations. The initial stage involves mechanical cleaning using soft brushes and skilled restorers to remove dust and dirt. In cases where mechanical methods are insufficient, chemical cleaning solutions and solvents such as acetone and alcohol can be employed [58, 59]. Next, broken pieces are carefully assembled using Kemapoxy 101 SF with 3% nano- Al_2O_3 [31]. Afterward, any missing parts are completed, and thermal color treatments are applied. The examination of the window damage indicates a significant loss of glass panels. The original existing parts serve as a reference for studying the details of the missing glass pieces. Thermal color treatments involve oxides and color pigments, which are fixed by heating the glass pieces at temperatures between 500-600°C [12]. It is essential to replace any non-matching glass with colored glass that matches the original decoration in the window.

Furthermore, the weakened existing lead strips should be carefully reused by tightening them to restore their original shape and replacing damaged ones with modern equivalents. Soldering is performed to ensure the stability of the lead strips. Additionally, a putty mixture comprising calcium carbonate, linseed oil, and red lead oxide is applied to preserve and strengthen the glass fillings [60]. This putty mixture exhibits excellent adhesion to lead and glass and effectively withstands heat and humidity. Moreover, it is necessary to use natural oils as fungicides, as they can inhibit the growth of fungi, including clove and cumin oils, mixed in a small proportion (0.5%) with consolidation materials [61]. For consolidation purposes, it is preferable to utilize a combination of nano-alumina and nano-silica at 2% with Silres BS-290 at 7% [18]. Fig. 11 illustrates the window after the

imaginative conservation, with the missing parts completed using original decorations and colors.
