# EXPERIMENTAL RESEARCH CONCERNING WATERSIDE CORROSION OF FUEL CLADDING IN CANDU REACTOR

DUMITRA LUCAN<sup>1,2</sup>

**Keywords:** Zircaloy-4; fuel cladding; PHTS; water chemistry; corrosion.

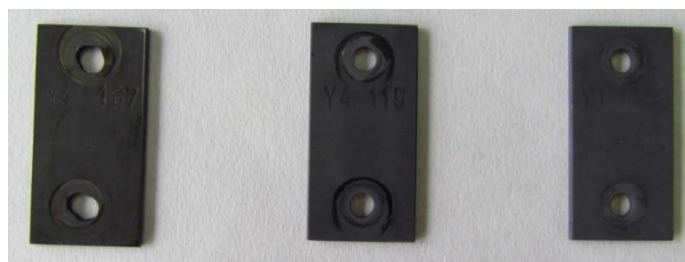
Figure 3. The aspect of coupons observed by visual examination.

The surfaces of the coupons were examined visually at low magnification or with a magnifying glass at 12X magnification to identify any defects due to corrosion. This analysis provides the first estimate of the state of the surfaces of the different components in the boiler. Upon visual examination of the Zircaloy-4 coupons, no differences were found between the two coupons in terms of the surfaces of the formed oxides. The coupons had no visible pores or cracks on their surface.

Both coupons had a surface completely covered with glossy black oxide. The oxide that forms on the zirconium alloys has a white color if the oxide is stoichiometric ZrO<sub>2</sub>, and the color black or grey is specific to a non-stoichiometric oxide ZrO<sub>2-x</sub>, adherent, or protective. It is expected that the oxide layer will have a small thickness and be uniform. The values of crud thus obtained are in agreement with theories that explain the mechanism of generation of corrosion products in CANDU reactors with carbon steel feeders. The coupons from the inlet reactor autoclaves (260°C) have larger deposits because the coolant is probably still supersaturated in iron concerning the solubility value and present a larger percentage (60%) of adherent crude deposited on the surface. The coupons inserted in the outlet reactor autoclaves (310°C) showed smaller values of total deposits and a smaller percentage of adherent crud (30%), which can be attributed to the presence of particulate matter formed by the erosion of recently precipitated crystals. In the case of tested coupons for 2520 days, the corrosion rate, determined by gravimetric analysis, was approximately 0.276–0.313 μm/dm<sup>2</sup>.day.

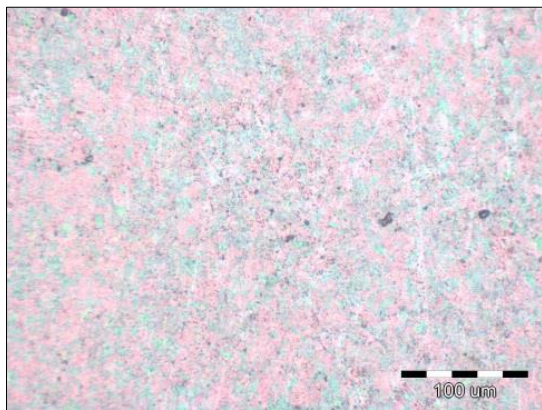
Figure 4. Zy-4\_Y2-77\_<5 years\_(x200).

The surface morphology of coupon Y2-77, exposed for <5 years, Figure 4 (x200), shows an adherent, glossy, black film with pink irises. The surface morphology of coupon Y3-259, exposed for >5 years, Fig. 5 (x200), shows a film adherent, glossy, black with dark grey.

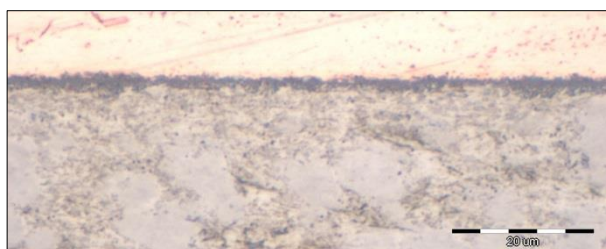
Figure 6. Zy-4 Y2-77.

The thickness of the oxide layer formed on the Zircaloy-4 coupon after 1440 days of exposure in the PHTS autoclave system is located in the range of 1.4-2.4 µm and after 2520 is approximately 2.6 µm.

The oxide layer on the Y3-259 coupon (autoclaved over 5 years, Fig. 7) was approximately 1.5 times thicker than that on the Y2-77 coupon (autoclaved under 5 years, Fig. 6).

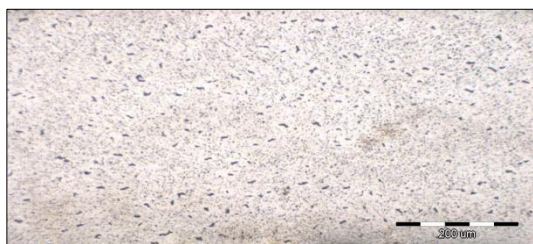
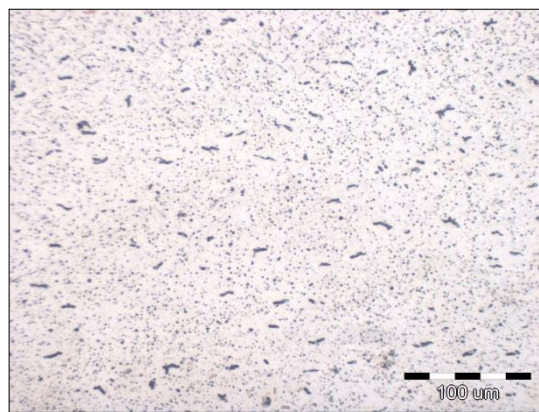
The microstructures of the control sample (as received) and Zircaloy-4 coupons show Zirconium alpha hydrides ( $\alpha\text{Zr}$ ) as can be seen in Fig. 8 (x100) and Fig. 9 (x200) – control of Zircaloy-4 (sheath): hydrides; Fig. 10 (x100) and Fig. 11 (x200) – coupon Y2-77, <5 years: hydrides; Fig. 12 (x100) and Fig. 13 (x200) – coupon Y3-259, > 5 years: hydrides.

Figure 8. Zy-4 as-receive: hydrides (x100).

Figure 9. Zy-4 as-receive: hydrides (x200).

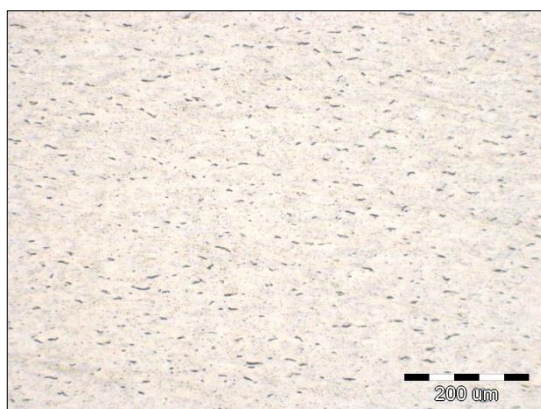
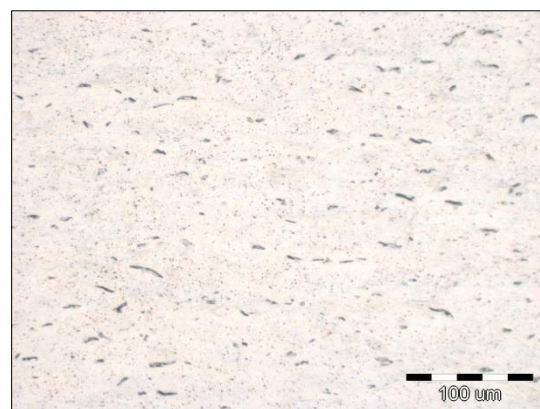
Figure 10. Zy-4\_Y2-77, hydrides (x100).

Figure 11. Zy-4\_Y2-77, hydrides (x200).

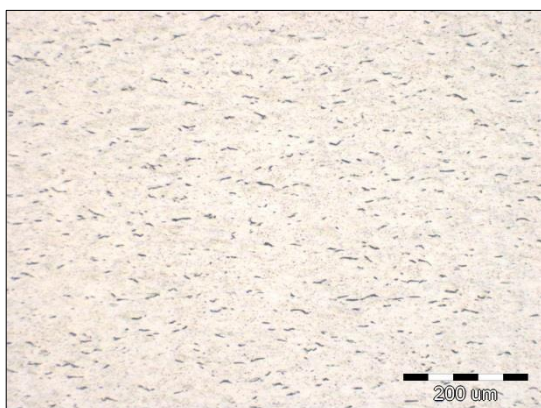
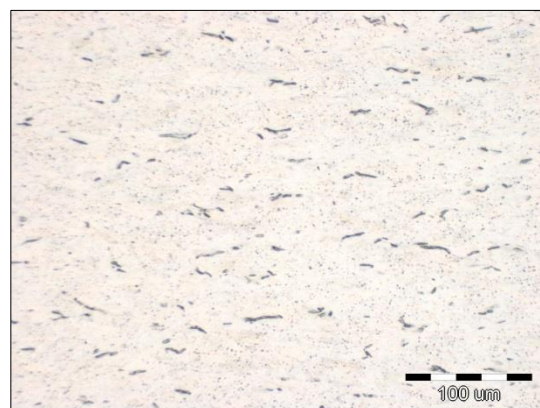
Figure 12. Zy-4 Y3-259, hydrides (x100).

Figure 13. Zy-4 Y3-259, hydrides (x200).

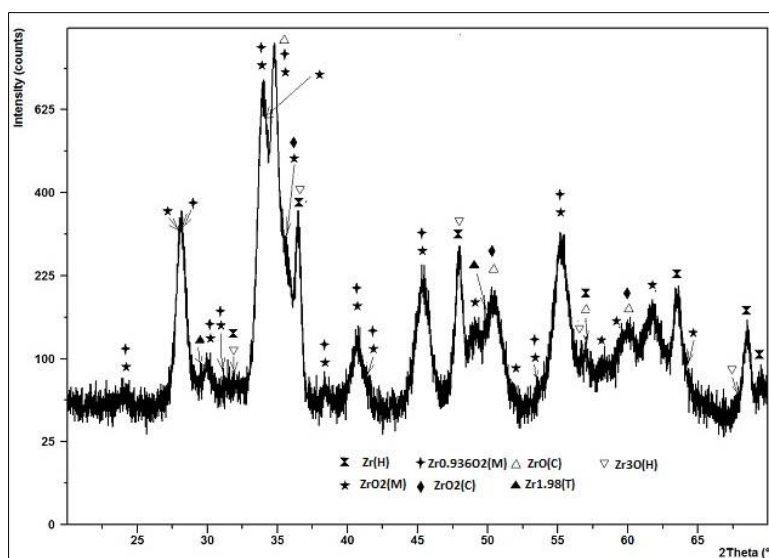
On the surface of the Zircaloy-4 coupon, the highest weight was obtained from the monoclinic form of zirconium dioxide. The tetragonal and cubic forms of zirconium dioxide appear with very little weight in the analyzed sample volume (3-4%). In addition, the hexagonal and rhomboidal forms of Zr<sub>3</sub>O and the cubic form of ZrO are highlighted in Fig. 14.

**Figure 14. The diffraction spectrum corresponding to coupon 259, exposed on support S6 of autoclave Y3 - circuit 2 (from the circulation pump to the reactor inlet).**

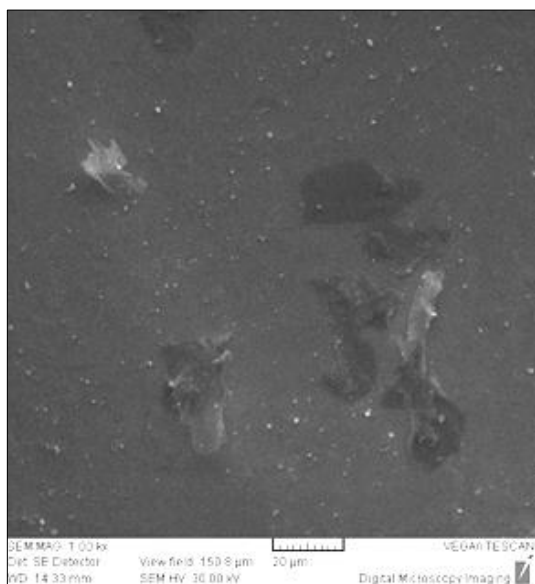
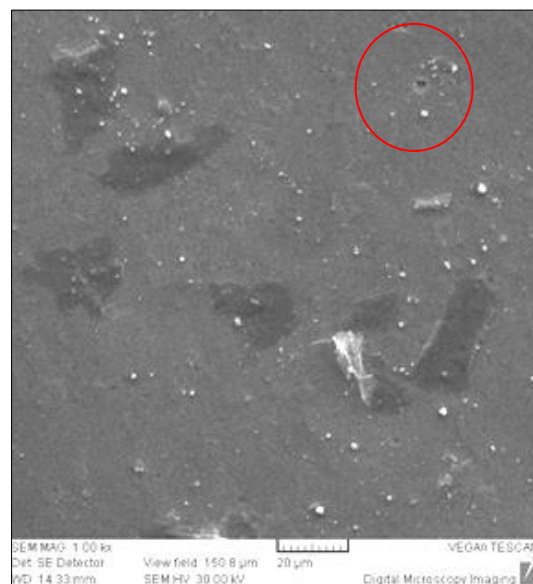
On scanning electron microscopy, the surface of the coupons in Zircaloy-4, coupon Y2-77 (subject to the corrosion conditions specific to the cooling agent in one of the loops and whose exposure period was less than 5 years) by scanning electron microscopy at x1000 magnification, Fig. 15, showed that the formed oxide is protective, does not show cracks, exfoliation or other surface defects. Throughout the coupon surface, pores smaller than 1  $\mu\text{m}$  were observed to form in or under a thin layer of oxide. In Figs 15 and 16, dark-colored deposits are observed on the surface of the oxide – identified by X-ray spectroscopy methods with energy dispersion – as carbon) and very fine nanometric crystallites are present on the surface. The small crystallites present on the surface are atypical for zirconium oxides; they can originate from the primary circuit by washing the oxides of other materials and subsequently fixing them on this coupon. Fig. 16 shows pores open on the surface, but many pores with very small nanometric dimensions were formed under the thin internal oxide substrate.

Figure 15. Surface of Zy-4 formed oxides (Y2-77).

Figure 16. Pores present on Zy-4 (Y2-77).

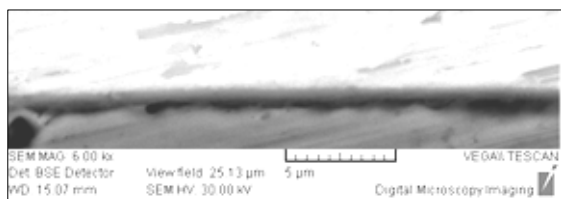
Figure 17. The oxide layer on Zy-4 sample Y2-77.

The images of scattered electrons taken in the cross-section of the Y2-77 coupon from Zircaloy-4 (Fig. 17) show the presence of a very small oxide layer, and the metal oxide interface is slightly corrugated. In the case of coupon Y3-259 from Zircaloy-4, Fig. 18 shows that the oxide has a small thickness, and the metal-oxide interface is slightly wavy. Very rarely, on the surface of zirconium oxide, there are deposited oxide particles brought by the cooling agent on the investigated coupon from other regions.

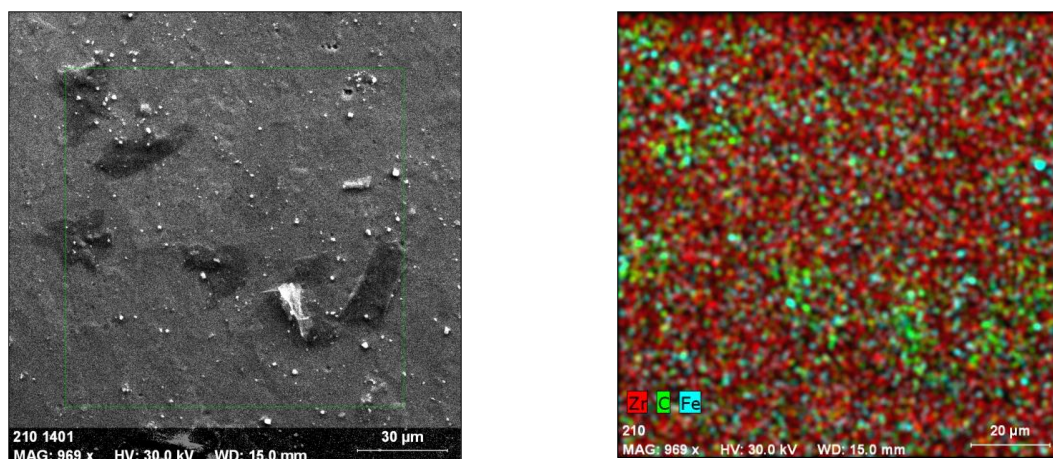
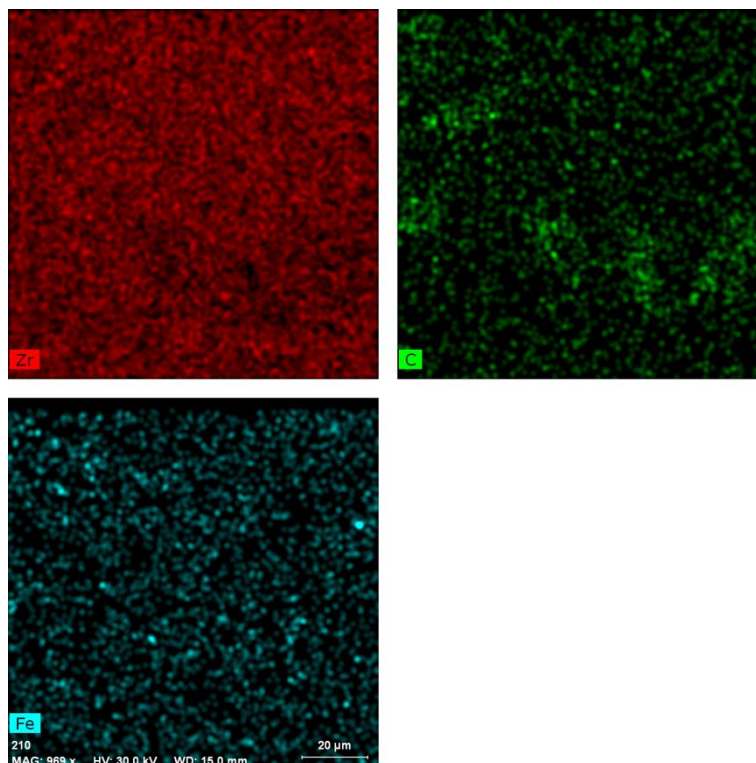
Regarding the Zircaloy-4 zirconium alloy, the surface deposits were examined, and from the cartographic images, it was found that the dark colored deposits (Figs. 19 and 20) were carbon, and the crystallites present on the surface were iron oxides transported by the primary agent and brought on the zirconium alloy coupons.

Figure 19. SEM image and EDS mapping of Fe, Zr, C on Zircaloy-4 sample - Y2-77.

Figure 20. Elemental cartographies Fe, Zr, C on Zircaloy-4 sample Y2-77
