ANALYTICAL INVESTIGATIONS ON A FIRED STUCCO WINDOW IN THE ISLAMIC ART MUSEUM STORE OF CAIRO, EGYPT

Abstract. *The stucco window in this study is kept in the stores of the Museum of Islamic Art in Cairo, Egypt, and bears the number 454/7. This window has been exposed to many damage factors, the most important of which is the fire that broke out in the museum in 2006 AD, in addition to the effect of the water that was used to extinguish the fire. This research aims to study the components of the window (stucco - glass - wood) and identify the transformations resulting from the effect of fire using optical microscopy, scanning electron microscopy coupled with EDX, X-ray diffraction, and infrared spectroscopy. In addition, the microbiological damage resulting from the moisture that saturates the plaster and wood was investigated.*

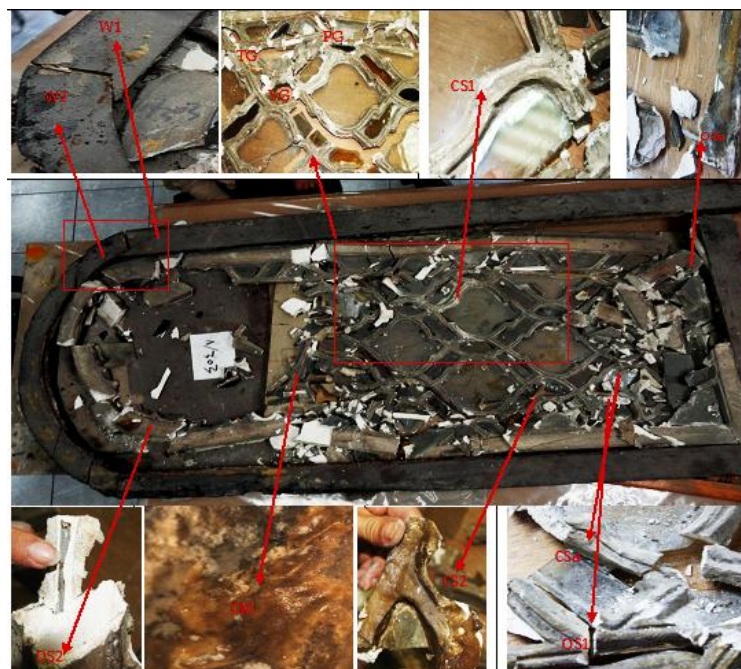
Figure 2. The places from where samples were collected for investigations

Twelve representative samples were carefully collected from areas of no aesthetic value, using a fine scalpel, to investigate the components of the stucco window and its deterioration (Table 1, Fig. 2).

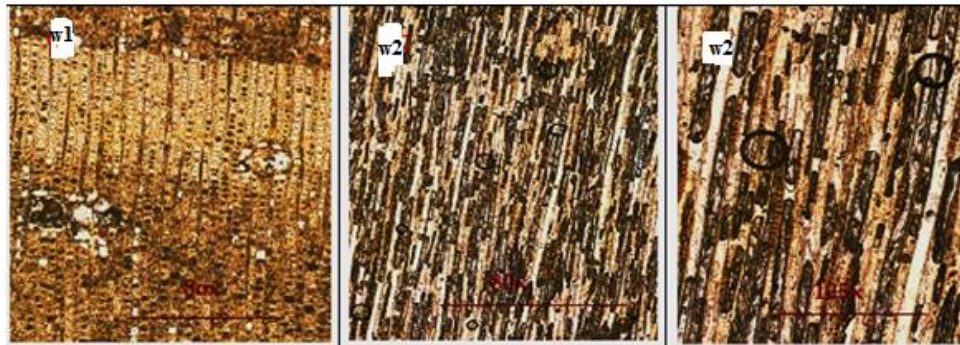
Microscopic investigation (Fig. 3) indicated that the wooden samples were identified as pine (*Pinus sp.*) softwood that grows in the Mediterranean region [21, 22]. The largest trees have a diameter of 50 cm and a height of 20 m [23]. Diagnostic characteristics have shown that the boundaries of the growth ring were distinct, thick-

walled xylem and axial intercellular resin present with thin-walled epithelial cells in cross-section (TS). In addition, the longitudinal cross-section (TLS) showed mono-rays with medium height (5–15 cells) and radial intercellular resinous channels [24, 25].

Figure 3 Anatomical characteristics of samples taken from frame wood confirm that it is pine wood by optical microscopy; (w1) Transverse section; (w2)- Tangential section.

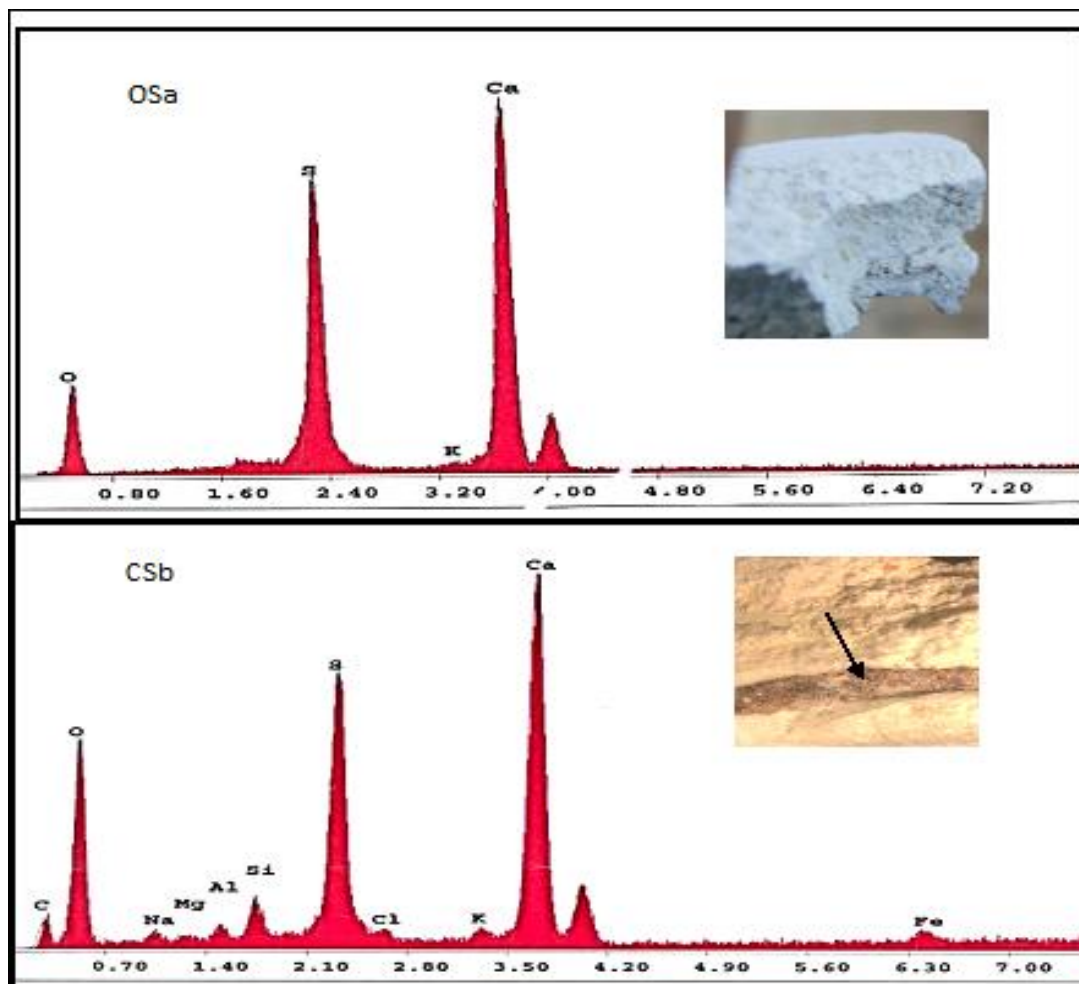
The results of EDX analysis of studied samples are presented in Table 2 and Figs. 10-11. Fig. 10 shows the presence of the following elements in the original stucco decoration of the window (*i.e.*, OSA): Ca, S, and O, which confirms that the main component is gypsum. In addition, for the sample of completion of stucco decoration (*i.e.*, CSb), it was confirmed the existence of an old previous restoration, and, in this regard, the following elements were proven Ca, S, O, C, Si and Fe. The presence of Ca, S and O elements confirms the presence of gypsum, while the presence of Ca, C and O highlight the presence of calcite. The presence of Si is evidence of the addition of sand when was made the restoring in the past. The element Fe also appeared as a result of the rust of the iron used in reinforcing the stucco frame of the window, as the exposure of iron to relative humidity (RH) and oxygen leads to the formation of iron oxides [11].

Figure10. EDX spectra of Stucco samples: (OSa) sample of the original stucco decoration and (CSb) sample of the completed stucco decoration.

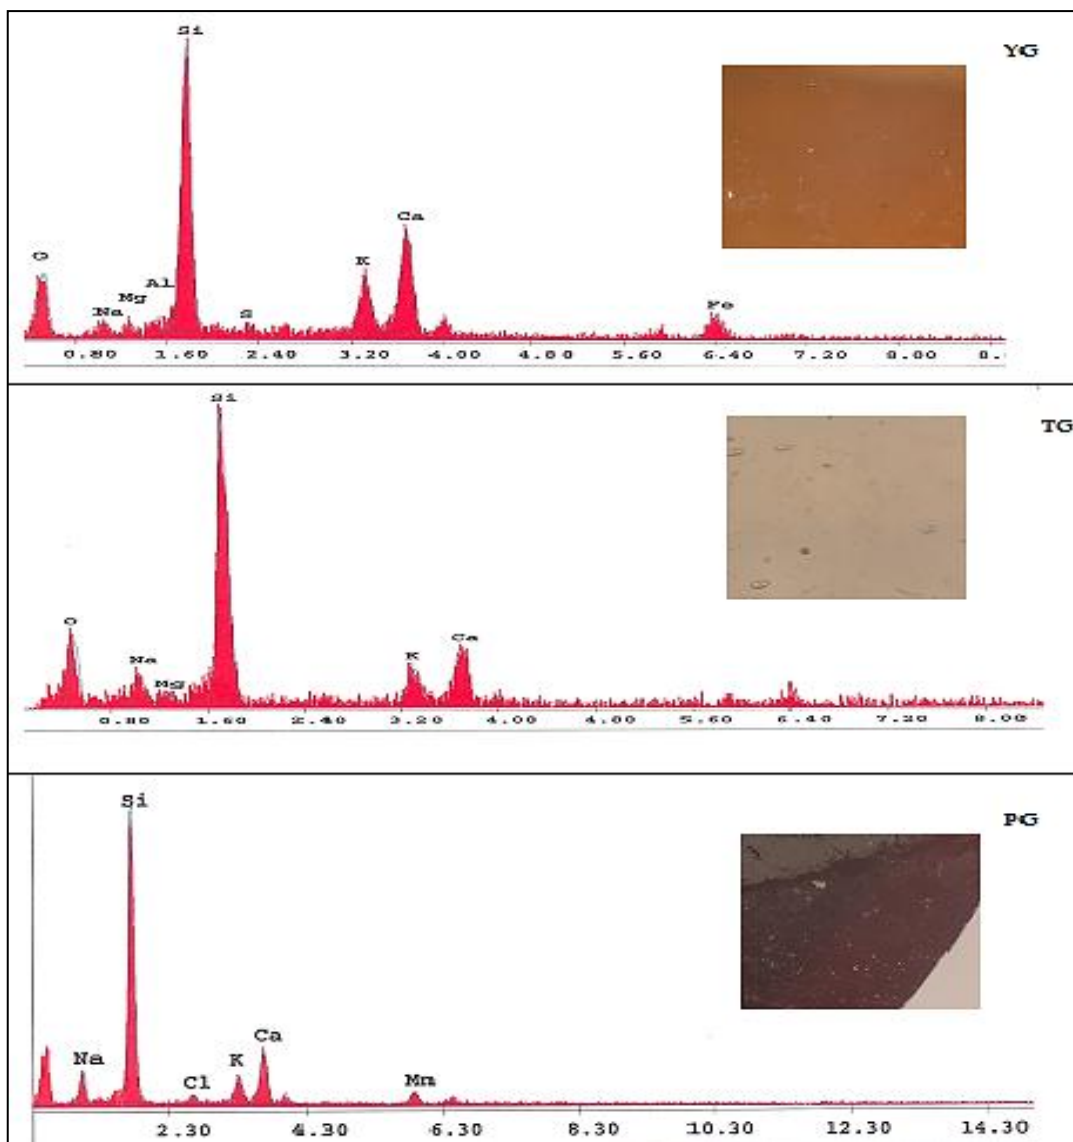
Regarding glass samples (Table 2, Fig. 11) is confirmed the presence of sodium (Na = 1.63%) and potassium (K = 5.92%), as main elements in the yellow glass (YG) sample. In addition to the low percentage of silica from its normal level, which represents (Si = 19.98%), as for calcium (the stable substance), it is suitable (Ca = 12.36%), and the presence of a high percentage of carbon (C = 30%), iron (Fe = 7.7%). The results proved the presence of magnesium (Mg), aluminum (Al), and sulfur (S) in small proportions, either as one of the additives that improve mixtures or as impurities [30].

The results of the EDX analysis of the transparent glass (TG) sample proved that the percentage of alkaline materials is typical, such as sodium (Na = 6.16%), potassium (K = 7.37%) and silica (Si = 38.63%). On the other hand, in addition to the presence of calcium (the fixing substance) (Ca = 13.66%), the results also showed a low percentage of magnesium (Mg), which is one of the improved materials in the glass industry, with no colored elements [30].

Figure 11. EDX spectra of Glass samples: (YG) a result of analyzing a yellow glass filler, (TG) a result of analyzing a transparent glass filler, and (PG) a result of analyzing a purple glass filler.

According to the purple glass sample (PG), the percentage of alkaline substances is as follows: sodium (Na = 6.61%) and potassium (K = 5.73%), which is a suitable percentage with the presence of calcium (the stabilizing substance) (Ca = 12.19%) in this ratio to make the glass more stable against deterioration factors and this confirms the stability of the purple glass and the presence of the silica ratio, which represents (Si = 38.61%). This means that the percentage of silica is typical, which increases the stability of the samples. As for the presence of manganese (Mn = 6.60%), it is responsible for the presence of the purple color [16, 31] and because of the high percentage of it, the purple color is darkened, as the presence of manganese in the sample in a ratio of (1.5:4%) gives the purple color, and as the ratio increases, the color darkens [28].

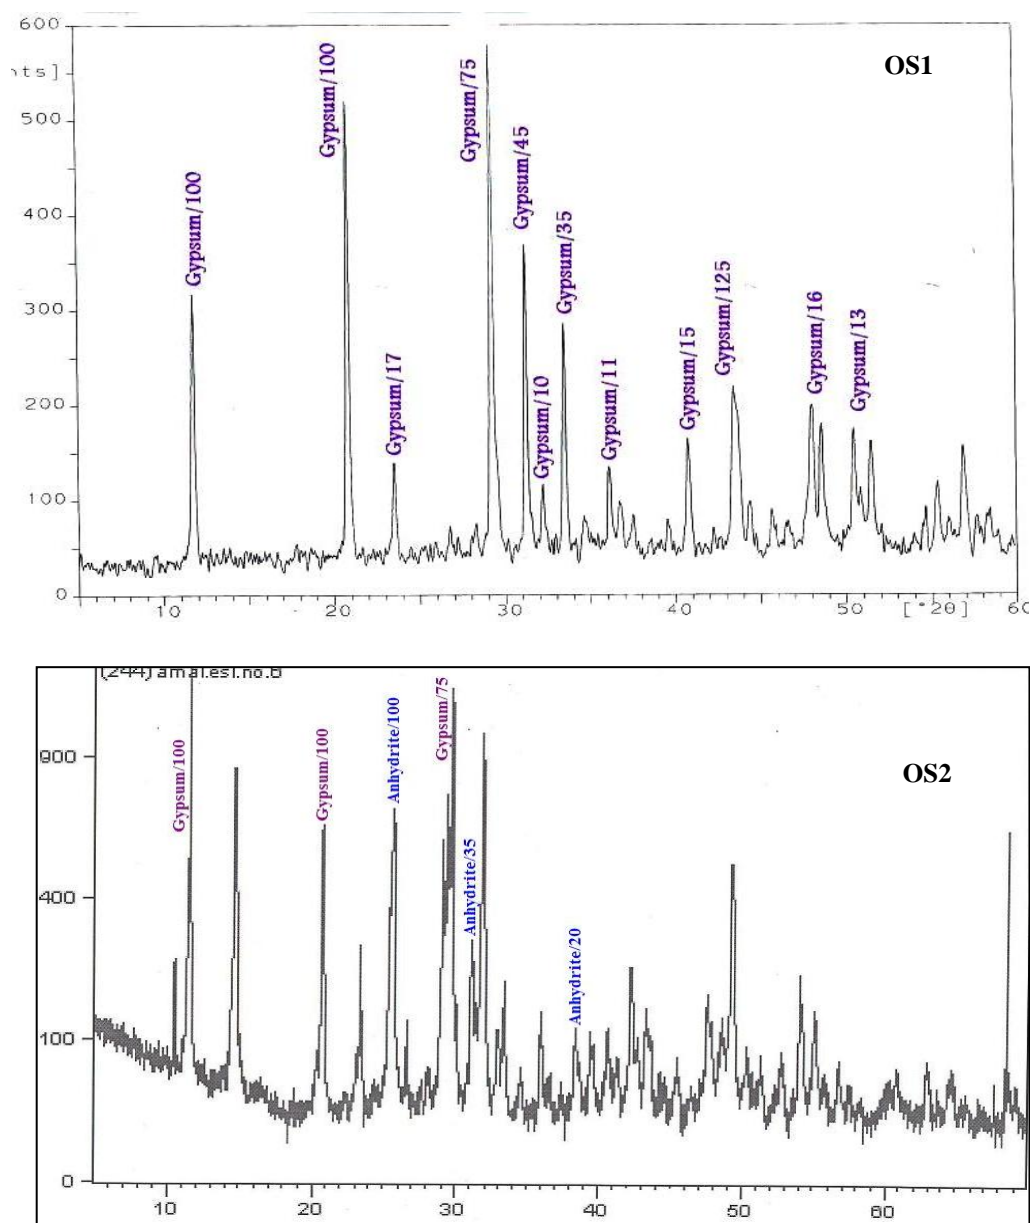
The results of the semi-quantitative XRD analysis of the mineral components of the stucco samples are presented in Figs. 12, 13, and Table 3. Fig 12 (OS1, OSof 2) shows the result of analysed samples of the original stucco decorations for the window. The results confirm that the main component of the original decorations is gypsum. Anhydrite also appears in the sample (OS2), and it is the result of exposure of gypsum to heat (fire). It can be concluded that a part of the gypsum is transformed to anhydrite, which weakened the decorations. [5,7]. Fig.13 (CS1 - CS2). shows the result of the analysis of the completed stucco decorations (previous restoration). The results confirm the existence of a false restoration, which is the use of a mortar that is different from the original mortar. The sample (CS1) consists of calcite (29.5%) and quartz (67%). The sample (CS2), consists of gypsum (65%), quartz (26%) with hematite (9%) as a result of the rust of iron used to reinforce the plaster frame of the window [11].

Figure 12. Samples (OS1-OS2) of the original stucco decoration which the major compound is gypsum.

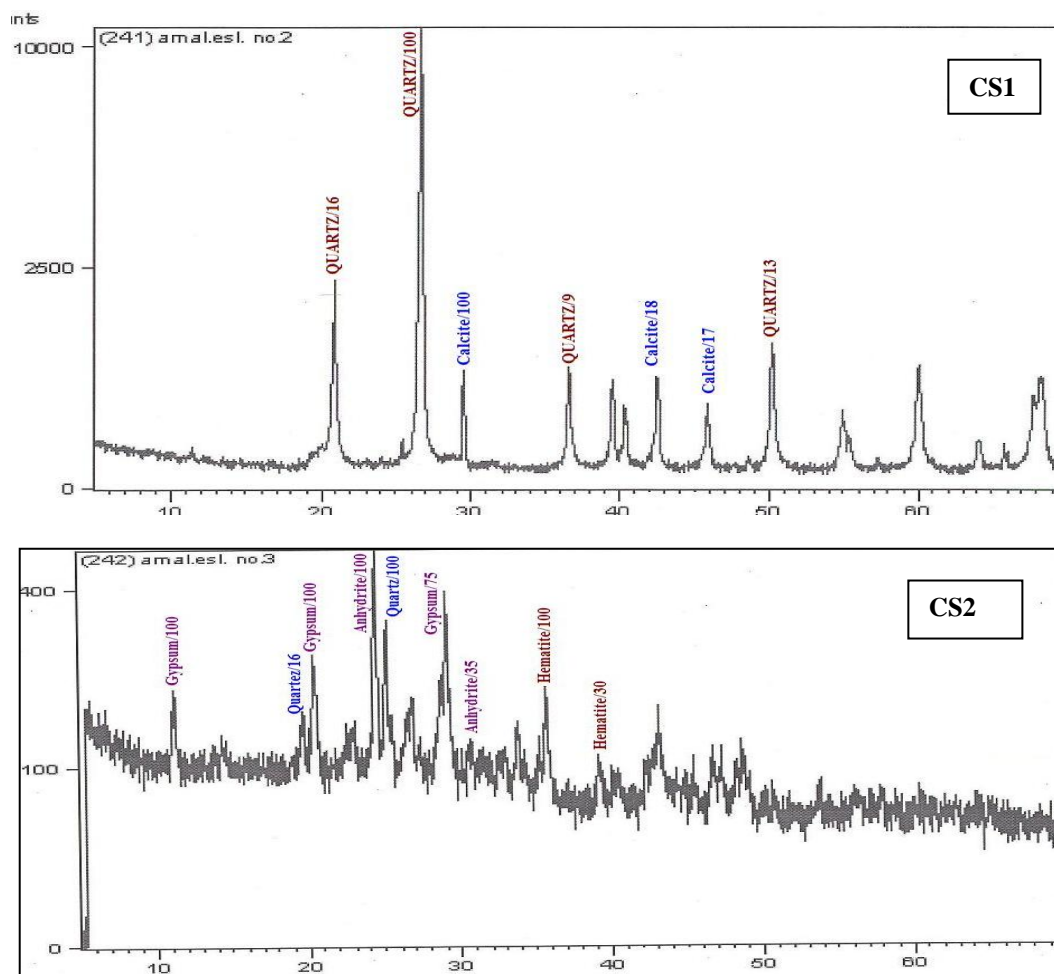
Figure 13. Sample (CS1-CS2) of the modern completed stucco decoration with new moderate with different compounds (calcite and quartz).

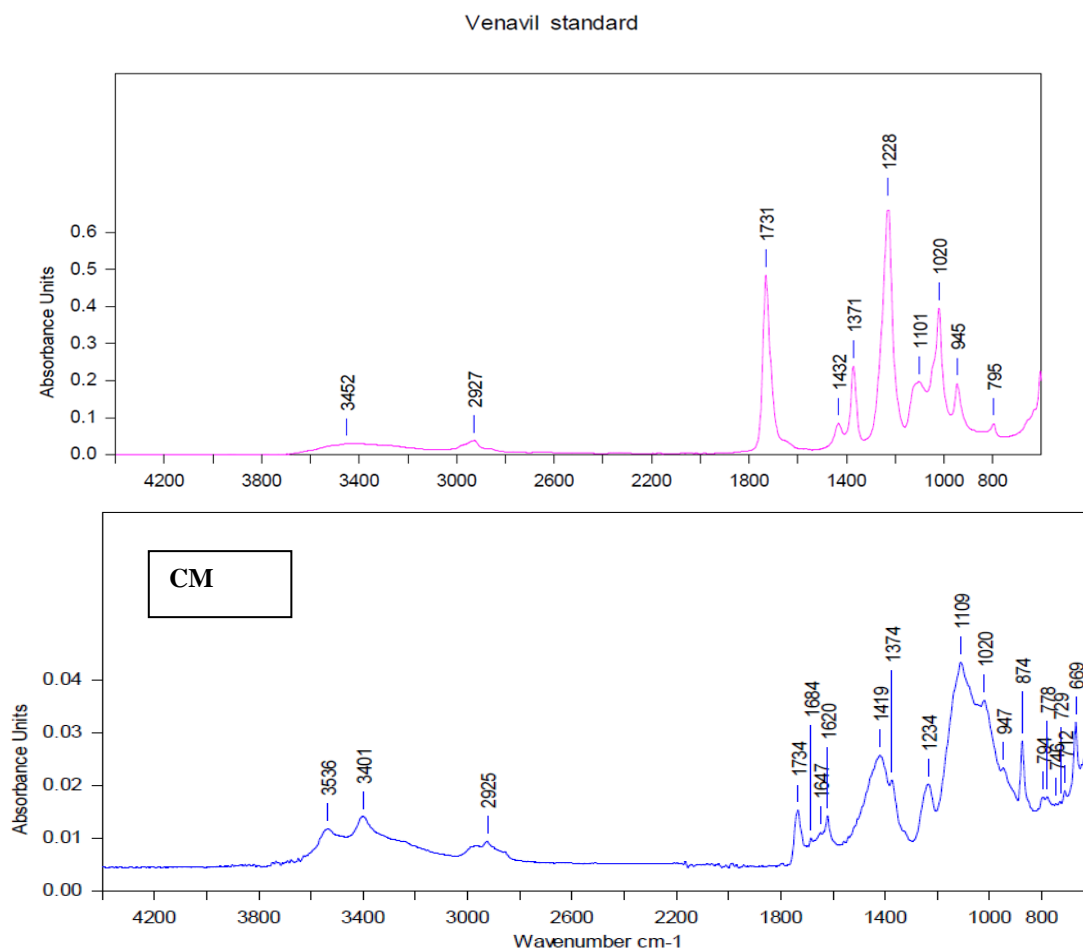
The results of the analysis using FTIR proved that the material used to consolidate the stucco decorations is poly(vinylacetate), acronym PVAc. This was confirmed by comparison with a standard sample (Fig. 14, Table 4). The FTIR data represents a distinctive fingerprint for each substance separately [32-37]. The molecular vibrations characteristic of poly(vinylacetate) is concentrated mainly in the region of 500-1700 cm^{-1} [35-36], but a wide band in the region 3401 cm^{-1} is attributed to the same structure PVAc [36]. On the other hand, the functional groups [37] were attributed as follows: 3100-2800 cm^{-1} to the C-H stretching bands; 1750-1650 cm^{-1} to the C=O stretching band; 1480-1300 cm^{-1} to the C-H bending bands; 1300-900 cm^{-1} to the C-O stretching bands. Poly(vinylacetate) is one of the water-soluble polymers [38], which has been widely used

Figure 14. FTIR spectra of the standard of poly(vinylacetate) and the sample of the consolidation material (CM).
